10 AND 11 TYPE BELLS

AND

10 TYPE BUZZERS

REQUIREMENTS AND ADJUSTING PROCEDURES

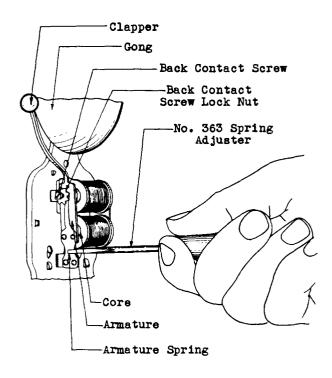
Fig. 3 - Method of Tensioning Armature Spring

- M-7 If the armature travel is satisfactory, the failure to operate is probably due to excessive tension of the armature spring. Reduce the tension of the spring by adjusting it close to the base of the spring with the No. 363 spring adjuster as shown in Fig. 3. Take care not to kink the spring in making this adjustment.

M-10 If the armature travel is apparently satisfactory, the failure to release is probably due to insufficient tension of the armature spring. To increase the armature spring tension, adjust it close to the base of the spring with the No. 363 spring adjuster as shown in Fig. 3. Take care in making this adjustment not to kink the spring.

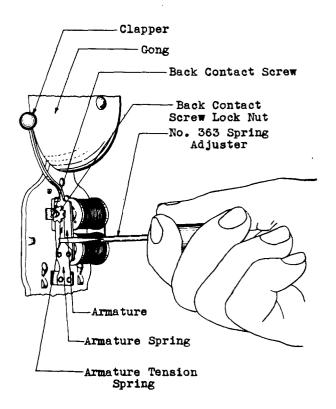
Fig. 4 - Method of Tensioning Armature Tension Spring

M-ll If the sound is not loud enough, increase the tension of the armature tension spring by applying the No. 363 spring adjuster close to the base as shown in Fig. 4, and giving the adjuster a slight twist in a direction which will increase the pressure of the spring against the back contact screw. If the sound is too loud decrease the tension of the spring. Take care not to kink the spring in making this adjustment.

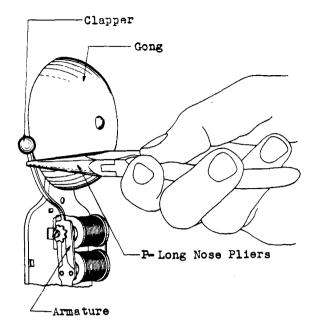
Fig. 5 - Method of Adjusting for Clapper Movement

M-13 If the armature vibrates uniformly but the clapper does not strike the gong, bend the clapper as required with the long nose pliers applied as shown in Fig. 5.
