**METHODS OF DENYING AND RESTORING SERVICE
ON CUSTOMERS' LINES
STEP-BY-STEP AND COMMUNITY DIAL OFFICES**

1.01 This section describes ways to deny and restore service on subscriber lines (individual and party) in step-by-step (SXS) and community dial offices (CDOs).

SECTION 226-155-300PT

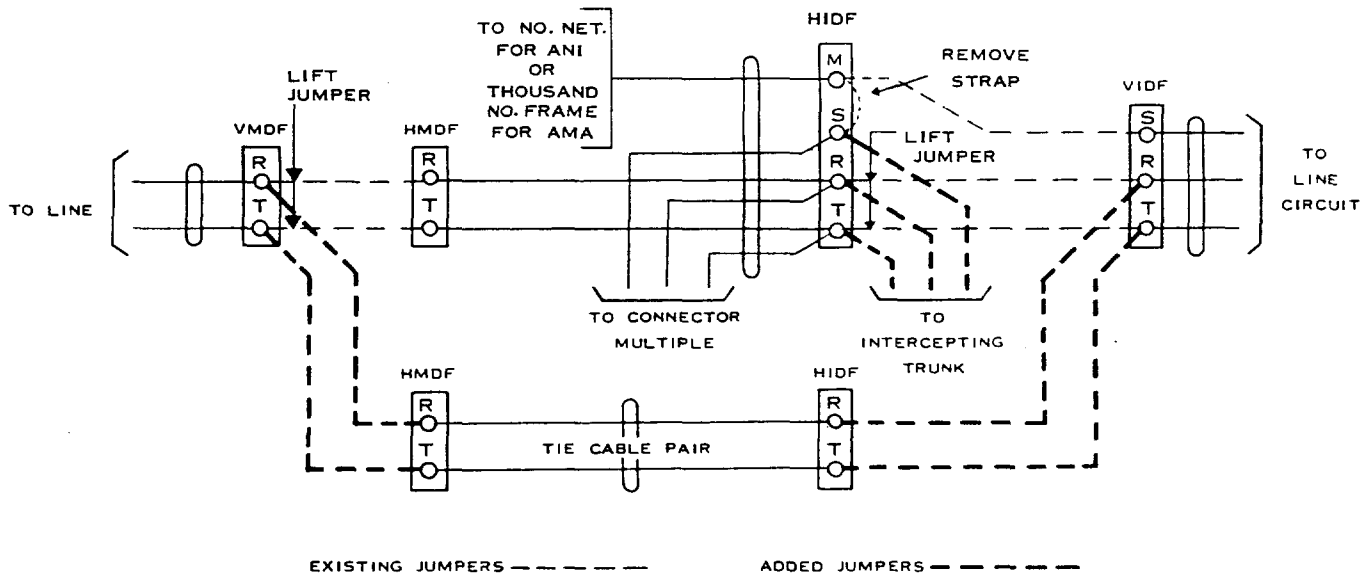
Fig. 3

**Temporary Denial of Incoming Service
Offices With The Connector Multiple On The MDF
AMA Offices, Also ANI-B Offices Where The Number
Networks Are Cabled To M Terminals**

(b) At the MDF, run a cross-connection from the cable and pair to the IDF tie pair used in (a). Lift the existing jumper at the cable and pair and connect the jumper from the IDF tie cable. (See Fig. 2 and 3.)
